# Toyota Electronic Throttle Control Investigation

## Preliminary Report

David W. Gilbert, Ph.D.

2/21/2010

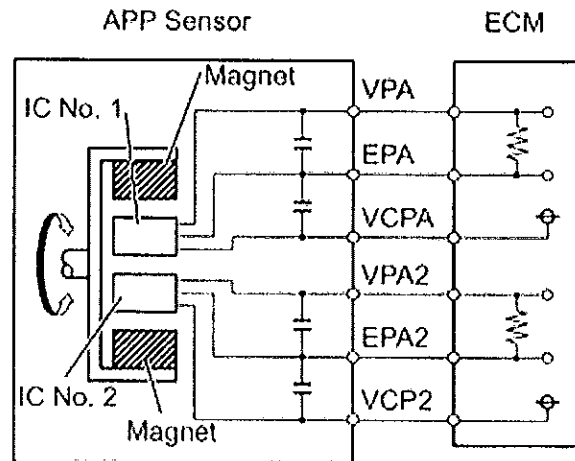
APP Sensor Circuit

Of particular interest were the APP signal inputs to the ECM. According to the Toyota TIS service information, the APP sensor is a non-contact type that uses two independent Hall-effect elements. As described, the APP sensor will have two completely separate sensing circuits: Voltage Pedal Accelerator (VPA), and Voltage Pedal Accelerator 2 (VPA2). Each sensing circuit will have a separate voltage supply circuit (Voltage Constant Pedal, or VCP), a separate ground circuit (Earth Pedal Angle, or EPA), and separate signal circuits (VPA and VPA2). The ETC system description further defines the two signal circuits as VPA (main) and VPA2 (sub). As TIS describes the circuit, the signal from VPA (main) "indicates the actual accelerator pedal opening

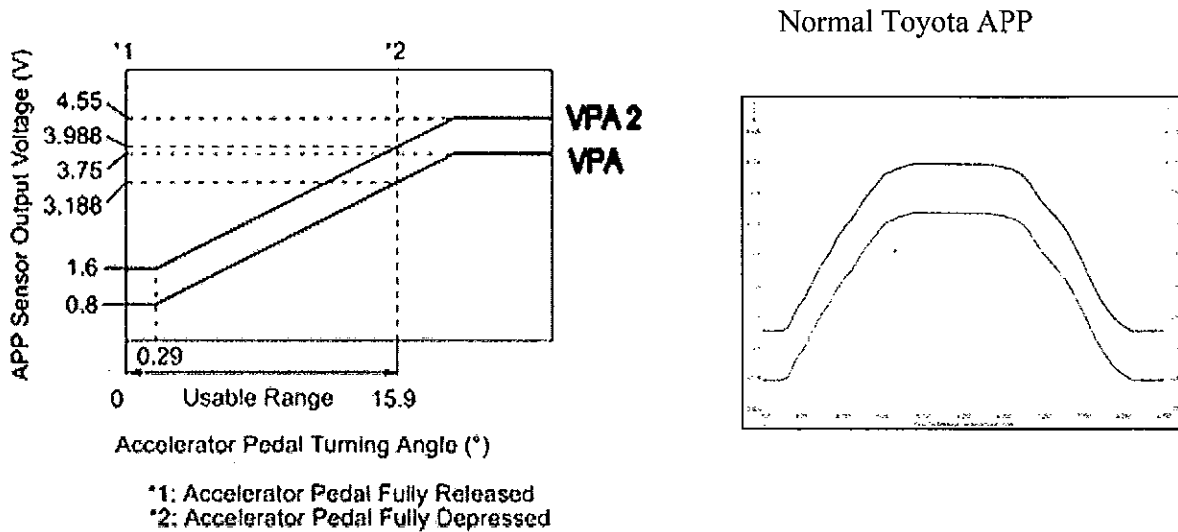
angle and is used for engine control” (Appendix: TIS Service Document, p. 1). Voltage limits for VPA, range from 0.4 to 4.8 Volts or more. The signal from VPA2 (sub) “conveys the status of the circuit and is used to check the APP sensor itself” (Appendix: TIS Service Document, p. 1). Voltage limits for VPA2, range from 1.2 to 4.8 Volts or more. Of important note, are the *overlapping* voltage values of the two APP signal inputs to the ECM.

Because their important role to accurately convey vehicle driver demands for throttle opening, APP sensor voltage inputs should always be confirmable by the ECM as absolutely correct. It was noted in the service literature that the threshold limits for a voltage difference of “0.02 Volts or less” between the two APP signal circuits should set a DTC P2138 (Appendix: TIS Document, p. 3). This voltage appeared to be an unusually close threshold value for a short between circuits. In other words, these two signal voltages could have been *almost* identical, and remain safely within the parameters of the P2138 DTC threshold limits. The VPA and VPA2 normally operate through a common range of parallel planes of voltage values. In addition, the two signal voltage values are normally supposed to rise and fall in unison with each other. If the two signal voltages

were in some fashion to become interconnected (shorted) through a certain amount of circuit resistance, the lower VPA voltage could be pulled up slightly in value. The higher VPA2 voltage could be affected in the opposite manner and pulled down slightly in value. At the same time, both sensors could conceivably stay within the upper voltage boundary of 4.8 Volts or more for the P2123 and P2128 DTC criteria. Similarly, the VPA2 1.2 Volt low threshold limit value for a P2127 DTC would not be reached, and the VPA 0.4 Volt low threshold limit value for a P2122 DTC would not be reached. Signal interconnection through resistance could then potentially tie the two circuits together without setting a DTC. At that point, APP signal circuit redundancy is lost and neither signal circuit is verifiable by the ECM as defective. The ECM will only react to defective voltages outside of the range of programmed limitations-so if the circuit is not defective; it must be good. Without a DTC set, the ECM will not logically enter into a fail-safe mode of operation.

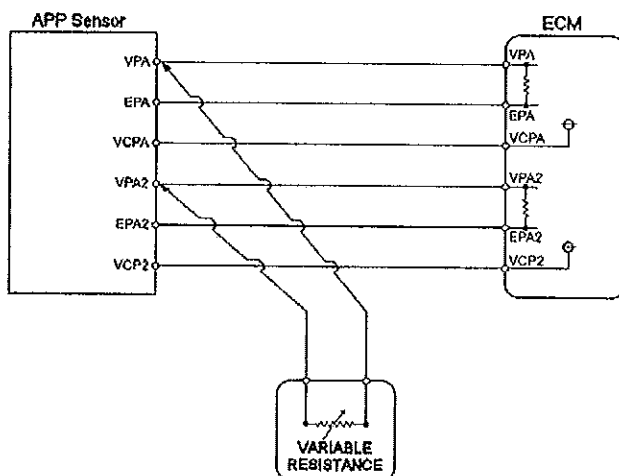
Validation testing began with DTC P2138, which is intended to detect abnormal conditions concerning the APP sensor, the ECM, and short circuits between VPA and VPA2 circuits. While monitoring APP signal voltages with the ignition “Key ON-Engine OFF” (KOEO), various resistances between the two APP signal circuits were introduced for trial. The effects of the different resistance values were recorded to determine the ECM’s actual circuit detection capabilities for this type of circuit malfunction. Ample time duration of “2.0 seconds or more” was allowed, as listed in the service literature for one trip detection logic. MIL illumination was used to signal the presence of ECM fault detection and subsequent DTC storage. It was soon realized that certain short circuit resistances between VPA and VPA2 were undetectable by the ECM. Once initial fault limitations were roughly established, “Key ON-Engine Running”(KOER) trials were conducted with similar fault detection procedures. Of particular interest was vehicle engine operation within the ECM acceptable voltage zone of a compromised VPA to VPA2 circuit short. The test vehicles generally ran well, in spite of the simulated signal circuit malfunction.

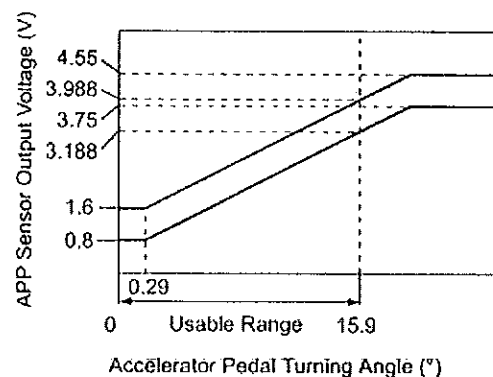
In review of the TIS service information, collected vehicle data, and performance observations; some general assumptions can be drawn from the research completed to date. The inability of the Toyota ECM to detect certain types of short circuit malfunctions could fall back to the basic design of the normal APP signal voltage limitations. The parameters for APP signal short circuit fault detection are apparently too lenient. In the Toyota ETC system, the APP sensor signal voltages rise simultaneously in direct response to accelerator pedal depression. With this design, interconnected signal circuits could be more difficult to identify with a circuit fault detection strategy that uses only threshold voltage limitations.
