# Toyota Electronic Throttle Control Investigation

## Preliminary Report

David W. Gilbert, Ph.D.

2/21/2010

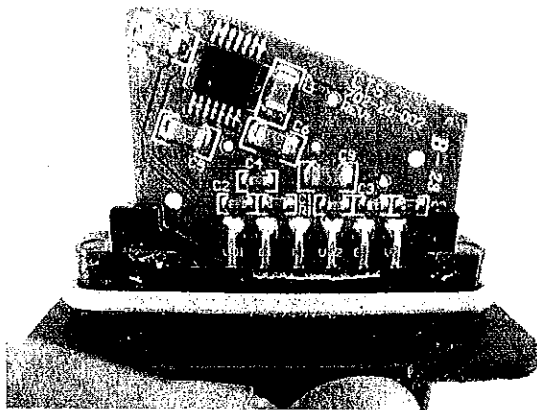
APP Sensor Circuit

Of particular interest were the APP signal inputs to the ECM. According to the Toyota TIS service information, the APP sensor is a non-contact type that uses two independent Hall-effect elements. As described, the APP sensor will have two completely separate sensing circuits: Voltage Pedal Accelerator (VPA), and Voltage Pedal Accelerator 2 (VPA2). Each sensing circuit will have a separate voltage supply circuit (Voltage Constant Pedal, or VCP), a separate ground circuit (Earth Pedal Angle, or EPA), and separate signal circuits (VPA and VPA2). The ETC system description further defines the two signal circuits as VPA (main) and VPA2 (sub). As TIS describes the circuit, the signal from VPA (main) "indicates the actual accelerator pedal opening

angle and is used for engine control” (Appendix: TIS Service Document, p. 1). Voltage limits for VPA, range from 0.4 to 4.8 Volts or more. The signal from VPA2 (sub) “conveys the status of the circuit and is used to check the APP sensor itself” (Appendix: TIS Service Document, p. 1). Voltage limits for VPA2, range from 1.2 to 4.8 Volts or more. Of important note, are the *overlapping* voltage values of the two APP signal inputs to the ECM.

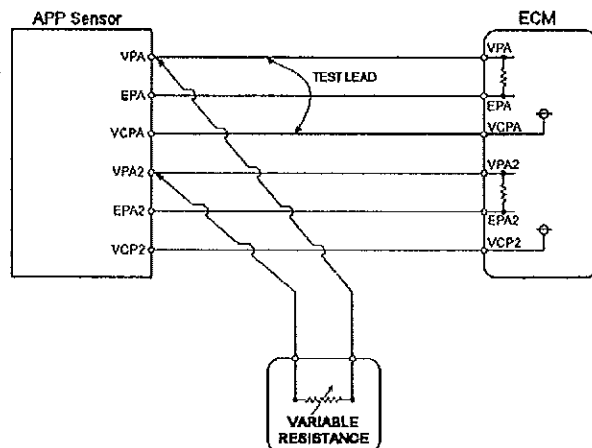
While running the engine in a VPA to VPA2 short circuit state, without MIL illumination or stored DTCs, accelerator pedal response rate and range was noted. Accelerator pedal observations were made with simultaneous brake pedal application, and without simultaneous brake pedal application. Recorded data, observations, and results were listed in detail for each specific test vehicle. To further test the absence of fault detection, experimentation was done to determine if the ECM would set a DTC with a combination of additional circuit abnormalities. Two combination tests were performed to include VPA and VPA2 shorted together (operating undetected), and circuit continuity to ground and power. The VPA and VPA2 signals operating in a short circuit state (undetected by the ECM)

were given a circuit path to EPA AND EPA2 (ground). Additionally, the shorted VPA and VPA2 signal circuits (undetected by the ECM) were tested with a circuit path to the VCPA and VCP2 (5 Volt supply). These tests were made during both: KOEO, and KOER conditions. Several different combinations of trials were made before discovering that when VPA and VPA2 were shorted together, with an undetectable resistance, and a connection was made from either VCPA or VCP2 to the VPA2 circuit *only* – both VPA voltages would rise together in unison. As a direct result of the connection to the VCP 5 volt supply circuit, the ECM responded by opening the engine’s throttle. Surprisingly, the ECM was repeatedly unable to detect this serious circuit fault abnormality. The vehicle showed no MIL illumination nor stored DTC in the ECM. Most alarming during KOER trials, the engine speed increased almost instantaneously to the full operating RPM limits of the engine. The resulting condition was also present with or without brake pedal application.

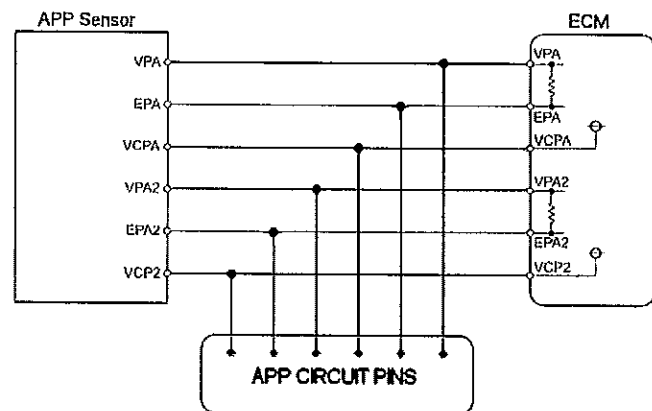
provided for a much safer laboratory testing environment. Evaluation tests were now more narrowly focused on the capabilities of the ECM to detect fault conditions to set a DTC P2138. DTC P2138 is the code used to detect the presence of a short between VPA and VPA2 signal circuits. Resistance values for shorted VPA and VPA2 signal circuits,

in combination with a short to the VCP 5 Volt supply circuit, were examined and recorded for threshold parameters. In addition, vehicles were tested to see if these shorted signal circuit conditions and WOT, could be active while the vehicle transmission was in drive and service brakes applied and released. For obvious safety reasons, these more extreme tests were performed outside the laboratory in an uninhabited open parking area.
